Joint Organisational Learning Action Note

Water Rescue Throw Lines – Safety Bulletin

Failure of a throw bag rescue line during a boat capsize rescue drill

MAIB SAFETY BULLETIN 2/2018

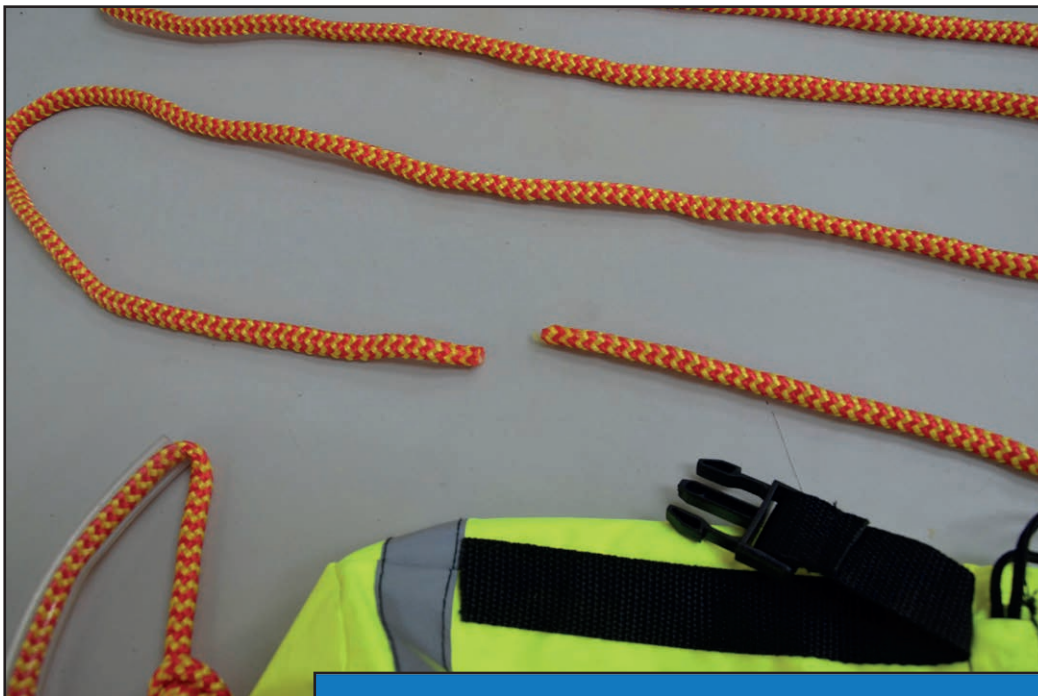
A defective throw bag rescue line was discovered while Warrington Rowing Club was conducting boat capsizing drills for new rowers at Halton Baths in Cheshire, UK. A 15m long polypropylene rescue line in a throw bag, supplied by Riber Products Limited (RIBER), parted (**Figure 1**) while a young person in the water was being pulled to the side of the pool during a simulated rescue. There were no injuries. The rowing club safety advisor subsequently found another throw bag with a defective rescue line that had been purchased from the same supplier. RIBER was informed and the company contacted its customers after identifying a batch of 208 throw bags that could be at risk. A further three defective rescue lines have been identified as a consequence of the customer warning notice posted on Facebook (**Figure 2**).

Figure 1: RIBER 15m throw bag rescue line

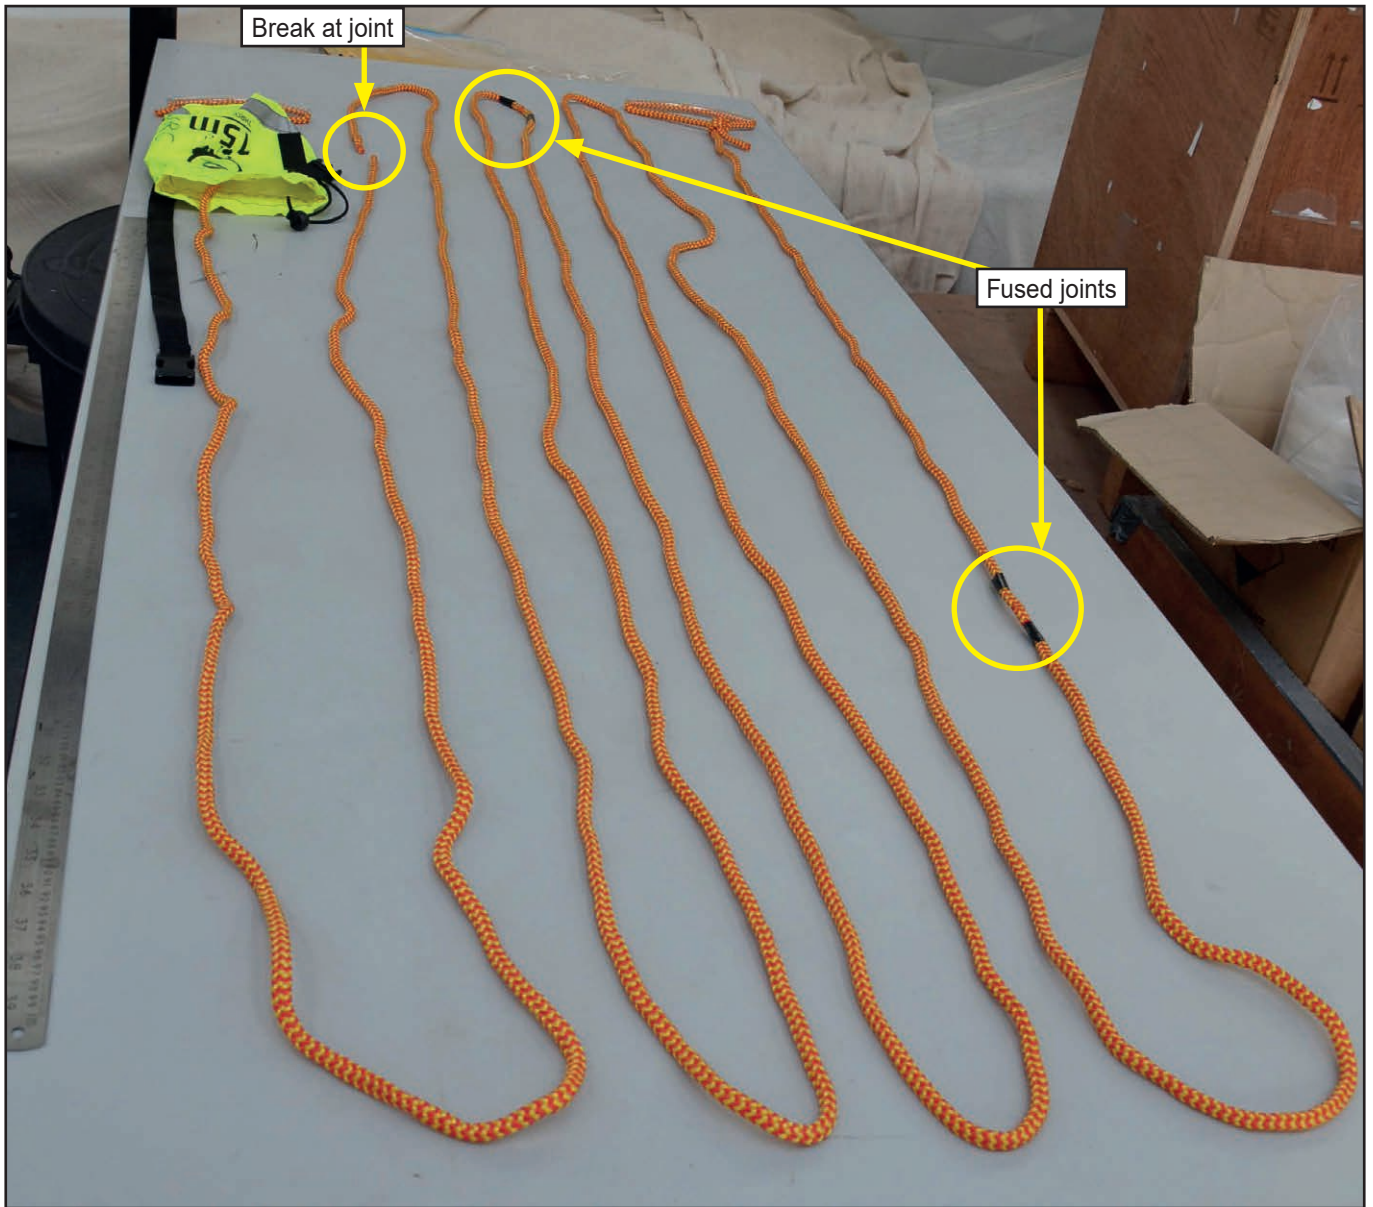
On inspection, the defective RIBER throw bag rescue lines identified by Warrington Rowing Club were found to have been made up of sections of polypropylene rope fused together, which broke easily at the joint when put under tension. One line was constructed of two sections of rope fused together, the other was constructed of four sections of rope, resulting in three fused joints in its 15m length (**Figure 3**). Intact and joined sections of one of the defective rescue lines were tested to determine the line's minimum breaking load. The intact section failed at 256 kgf (kilogramme force) and the joined sections failed between 19 and 23 kgf.

Figure 3: 15m rescue line with three joints

To ensure that throw bag rescue lines are fit for purpose they should be opened and checked. In particular:

- The entire length of the rescue line should be examined for joins or other discontinuities. This can best be done by feeling along the length of the line with bare hands to identify rough patches or lumps.
- Any knots, splices or other methods of securing the ends of the line to handles, quoits or other parts of the equipment should also be checked for integrity.
- The throw bag should be inspected and tried at regular intervals and repacked according to the manufacturer's instructions, as otherwise the line may not deploy freely from the bag when required.

Any throw bag rescue lines found to have joins or discontinuities should be removed from service and the original manufacturer /supplier informed.
