THE ICL INQUIRY

The ICL Inquiry Report

Explosion at Grovepark Mills, Maryhill, Glasgow
11 May 2004

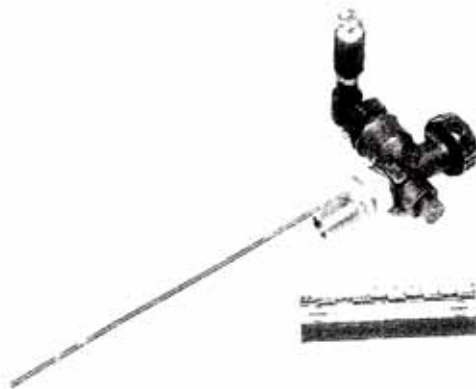
Figure 18 – The vapour take off valve fitted to the one-tonne propane storage tank

The one-tonne tank that had been fitted by Johnston Oils on 29 November 1998 was fitted with a vapour off-take valve (Fig. 18).

Although the valve appeared to have been originally fitted with an excess flow valve, which fitted into the base of the valve, the inner workings of the valve were absent when Dr Hawksworth inspected it. There was evidence that the working components of the valve had been in place at some time. This type of excess flow valve is intended to protect against a full pipe failure, or shear. It is not intended to offer any protection against a crack or a split in the pipe; nor to protect an underground pipe. The ICL installation was unusual in that there was no second stage regulator because of the high operating pressure of the oven.

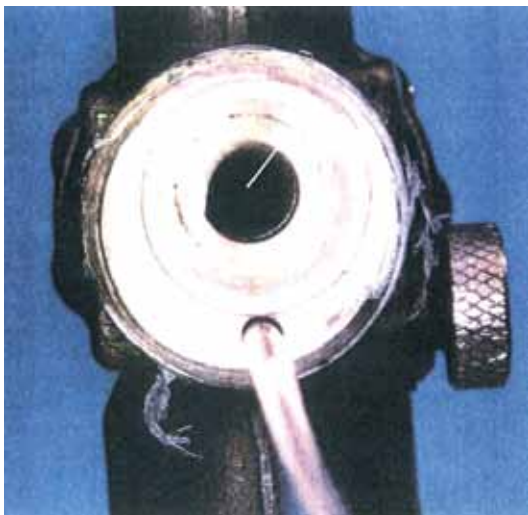
Figure 19 – The witness marks (arrow) left by the missing excess flow valve spring

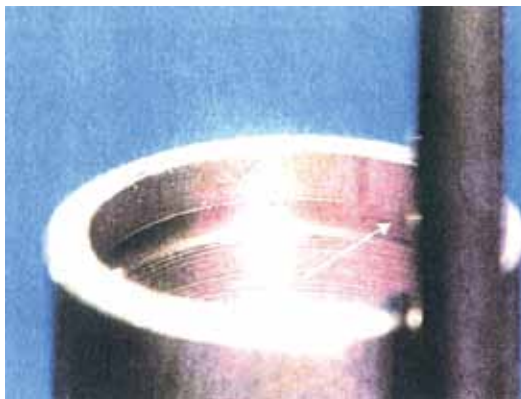
Figure 20 – The witness marks (arrow) in the circlip groove left by the missing excess flow valve circlip

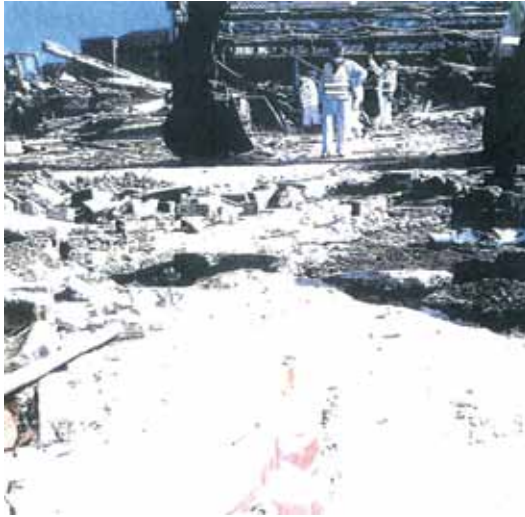
Figure 23 – The position of the LPG pipe as it enters the ground from the one-tonne propane storage tank end.

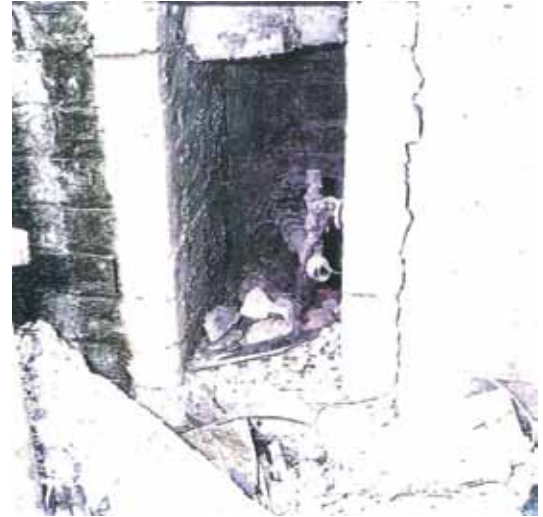
Figure 24 – The LPG underground pipeline enters the building in an alcove in the basement
