# The Ladbroke Grove Rail Inquiry

## Part 1 Report

**The Rt Hon Lord Cullen PC**

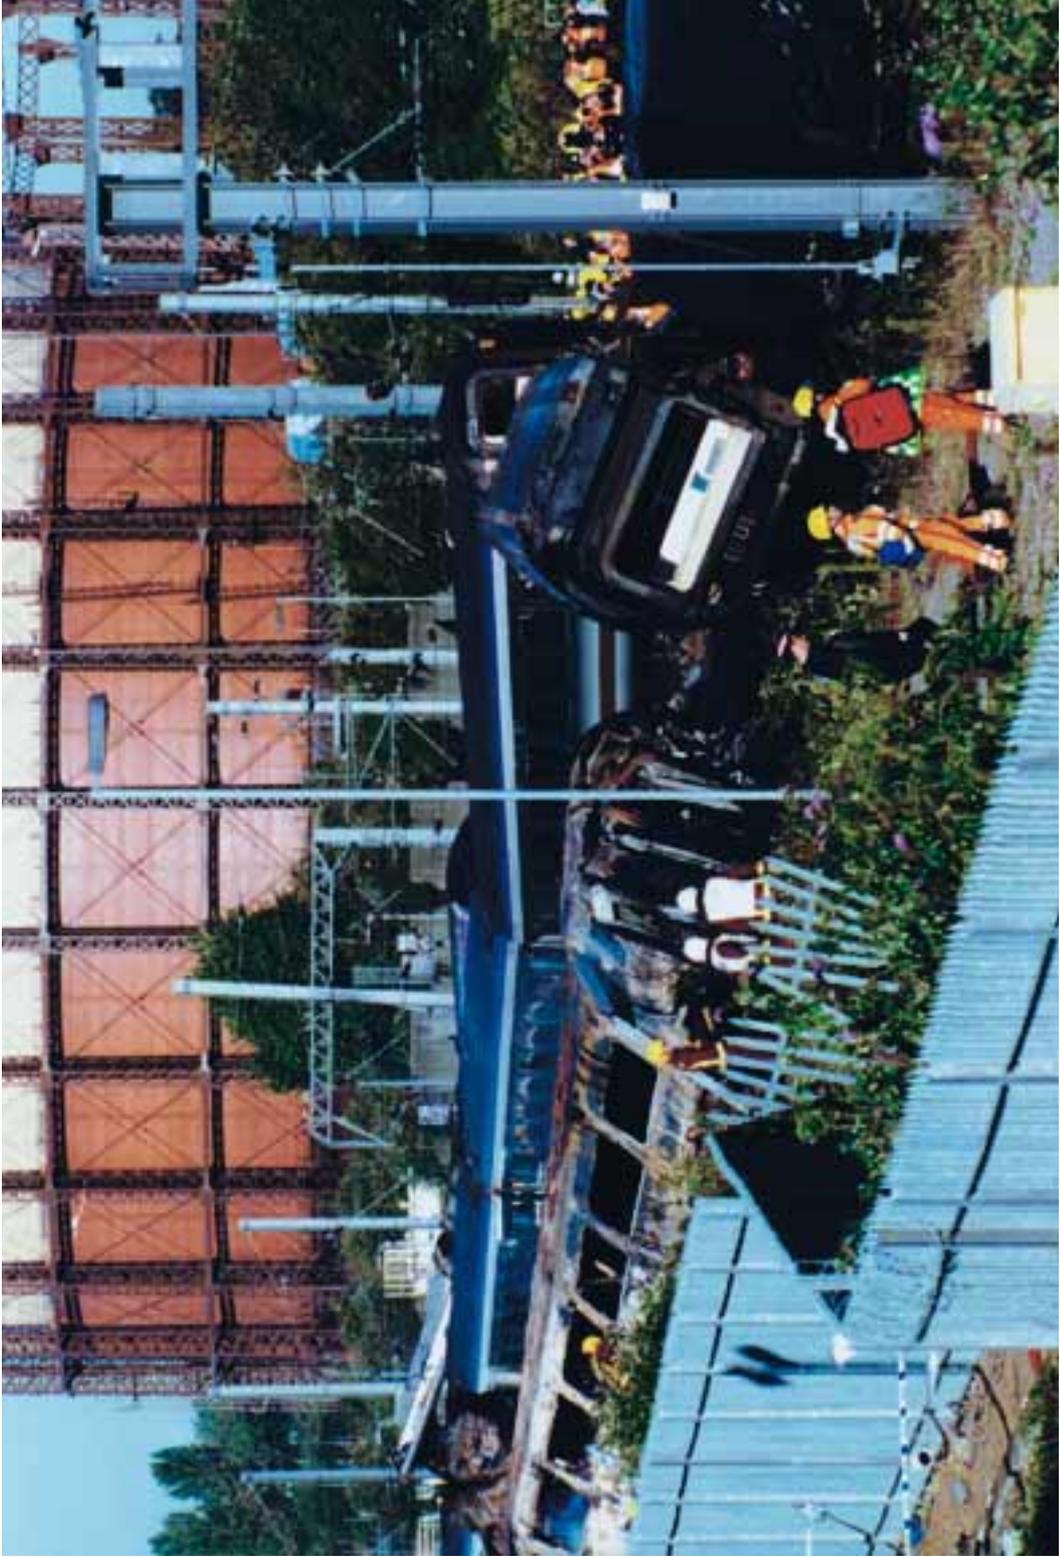
**Plate 11:** Crash site showing coaches F and H of the HST: view from the south-east.

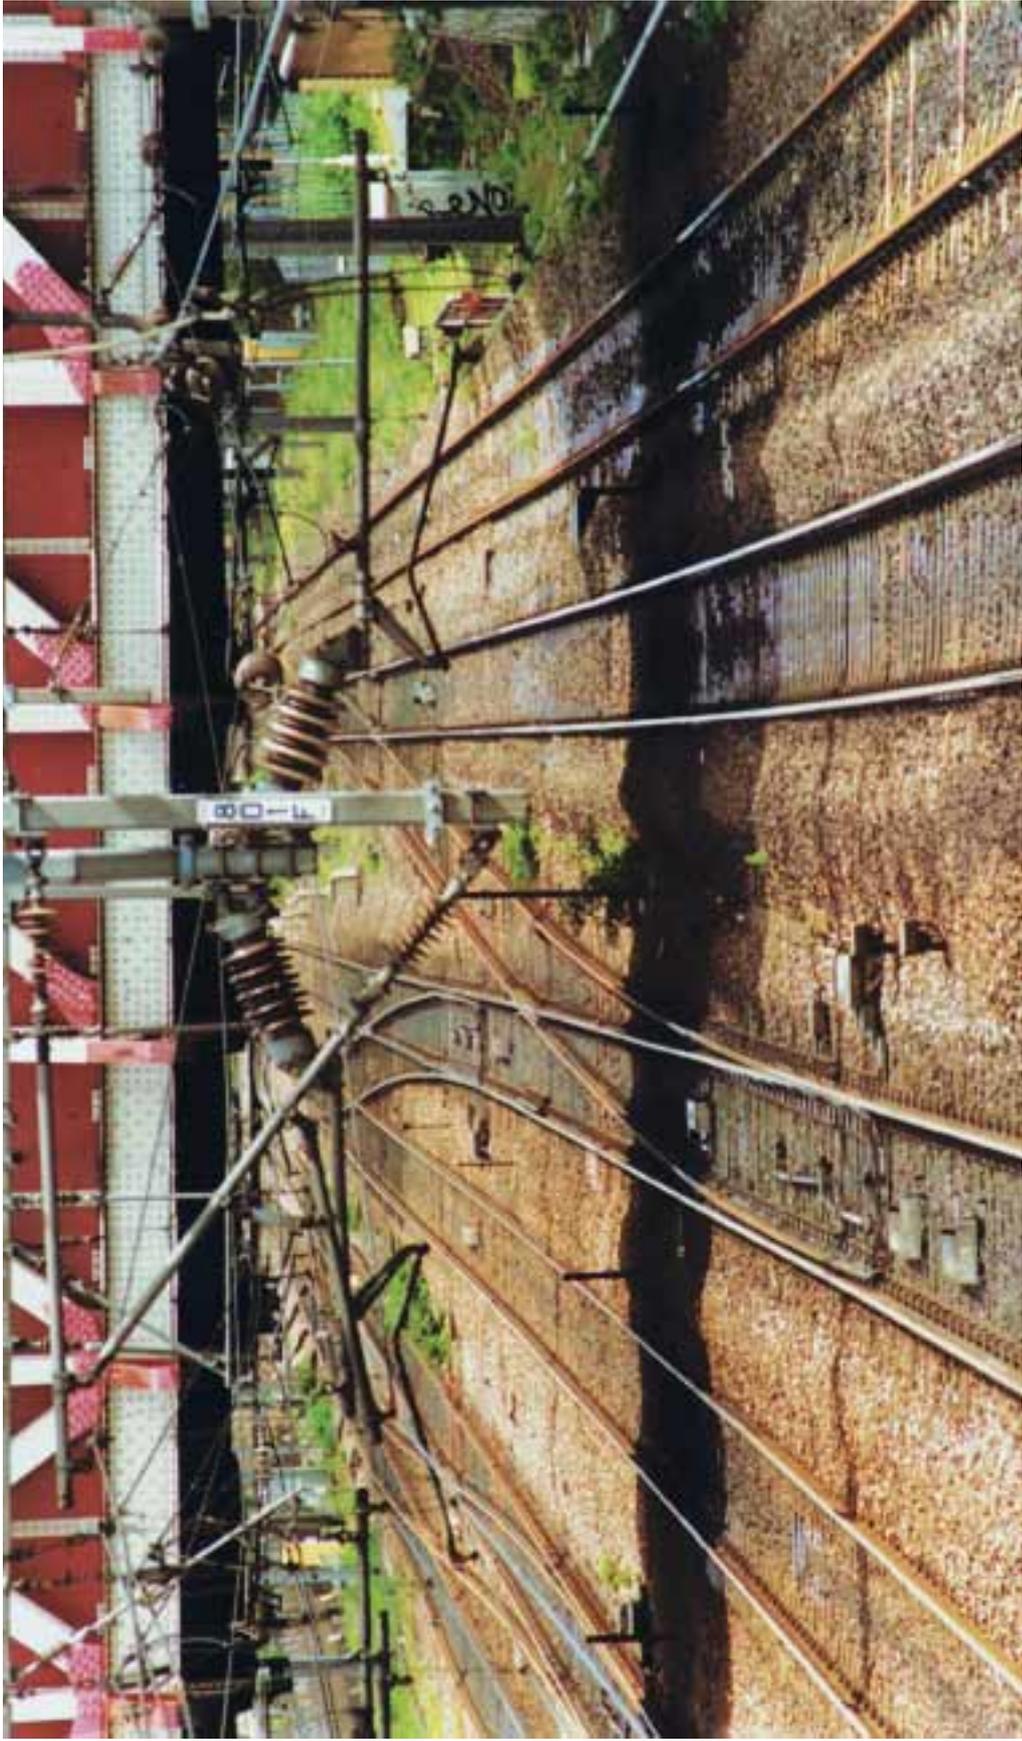
**Plate 14:** View towards Paddington. Taken from Gantry 8 with the camera placed directly above the red aspect of SN109. The lines are numbered 1 to 6 from right to left. SN109 applies to Line 3.
