The Southall Rail Accident Inquiry Report

Professor John Uff QC FREng

THIS Report follows an Inquiry held between September and December 1999 into the cause of a major rail accident which occurred on 19 September 1997 at Southall, 9 miles west of Paddington. The trains involved were the Great Western Trains (GWT) 10:32 Swansea to Paddington High Speed Train and a freight train operated by English Welsh and Scottish Railway (EWS), which was crossing the Up Main line to enter Southall Yard. Seven people died as a result of the accident and a further 139 people were injured, some severely. The Inquiry was set up within hours and directed to sit in public. The terms of reference are as follows :

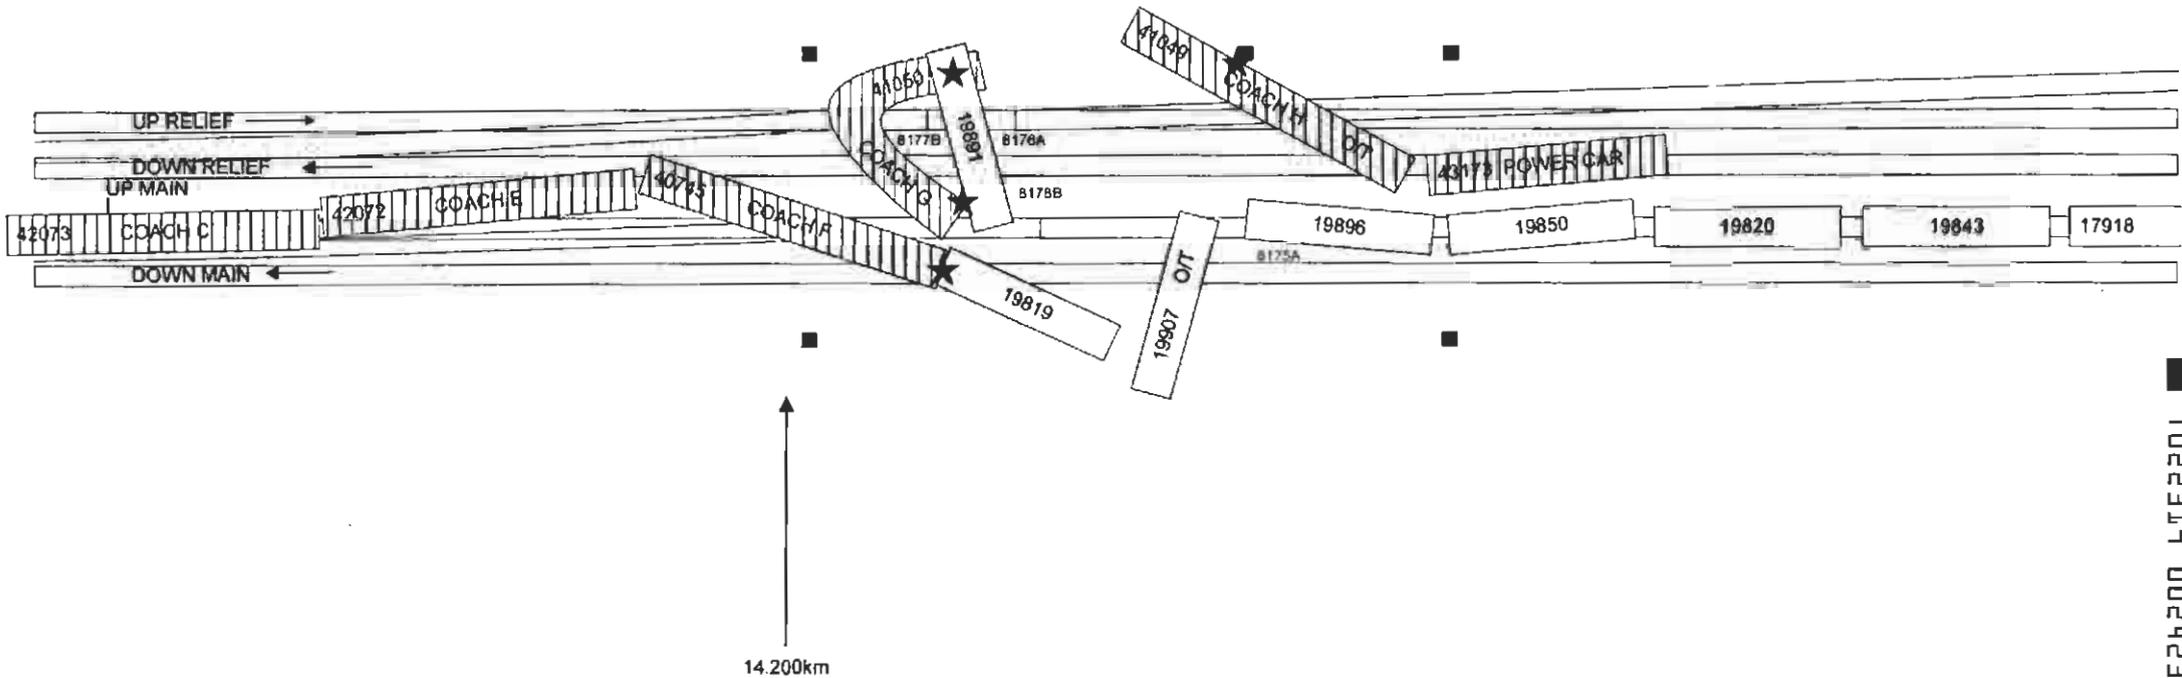
Crash site at time 8.5 secs after collision

Coach F impacts with Coach G which bends, allowing F to pass, colliding with wagon 19819.
 Coach H collides with the next overhead line stanchion and comes to rest upright.

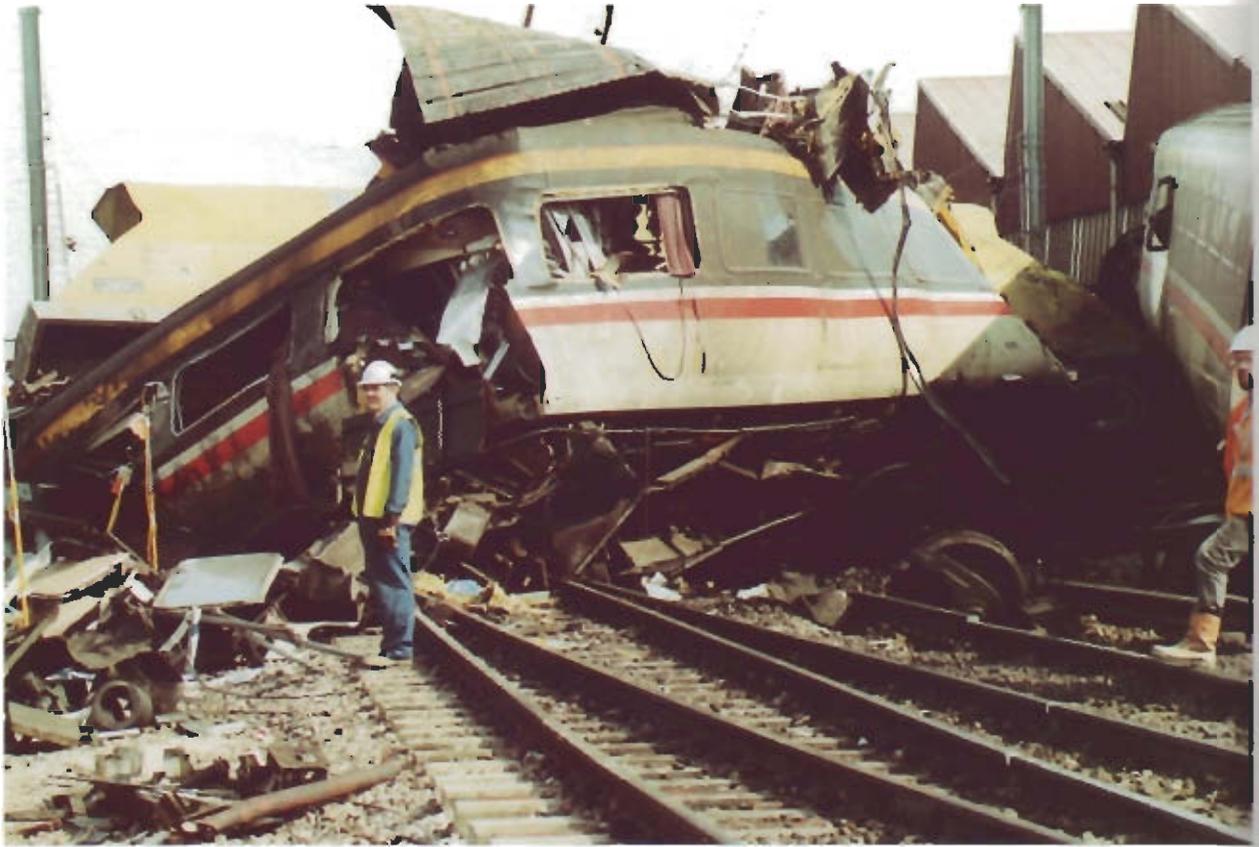
Damage to Coach G (main picture) and to Coach F (RHS)

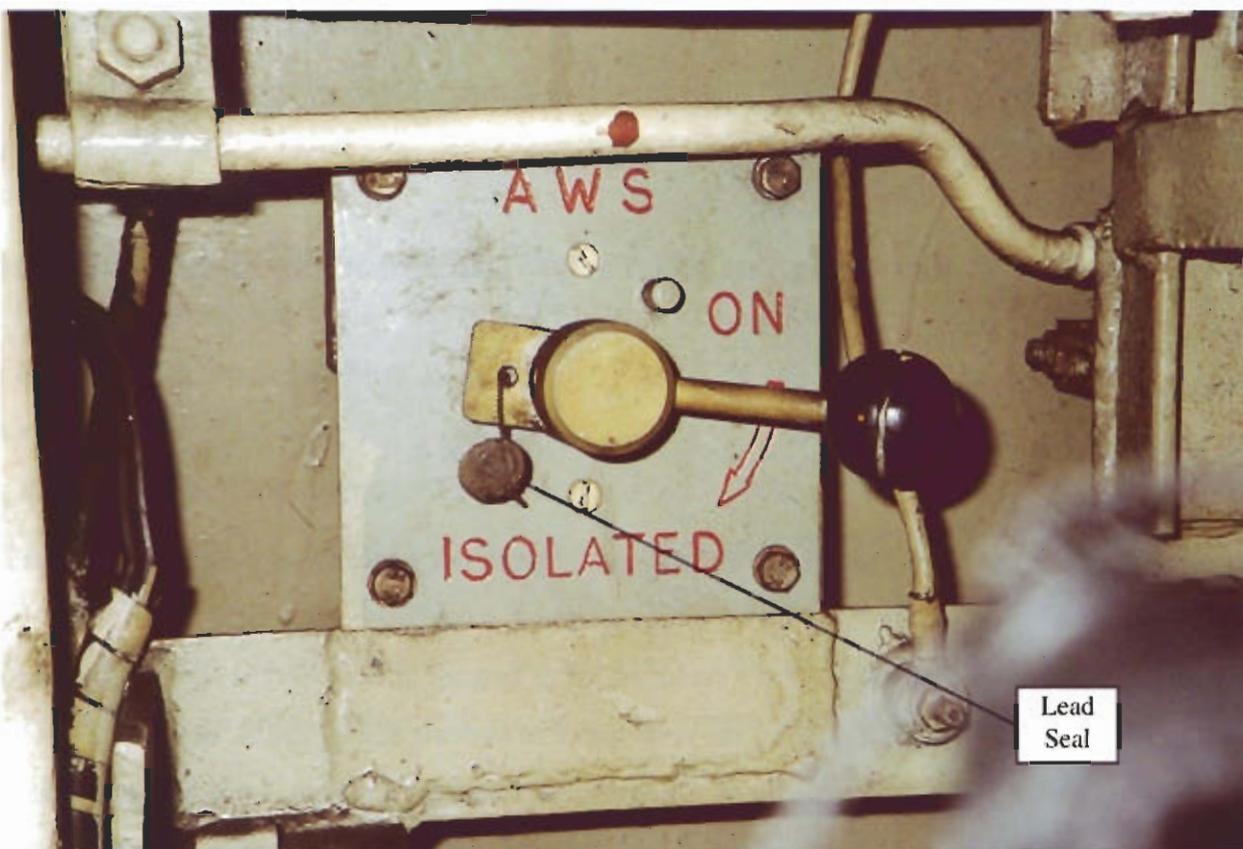
- 1.4 The second fault was more serious and had safety implications. The Automatic Warning System (AWS) in power car 43173 was not operational. It had been "isolated" by Driver Tunnock at Paddington Station after he brought the set from the depot at Old Oak Common. The AWS had operated normally during the short journey of 10 minutes from Old Oak Common. When he was in the station Driver Tunnock found that he could not cancel the AWS. He therefore had to isolate the system in order to release the brakes. Driver Tunnock reported both faults to George Barnfield, the Operations Supervisor at Paddington. Mr Barnfield's duties included passing drivers fit for duty, which he did both in respect of Driver Tunnock and a little later, Driver Harrison. During the short time Driver Tunnock was in Mr Barnfield's office a phone call was made, the intention of which was to report the faults to the GWT Control office at Swindon. The result of this call is considered later.

AWS Isolation Switch with lead seal in place

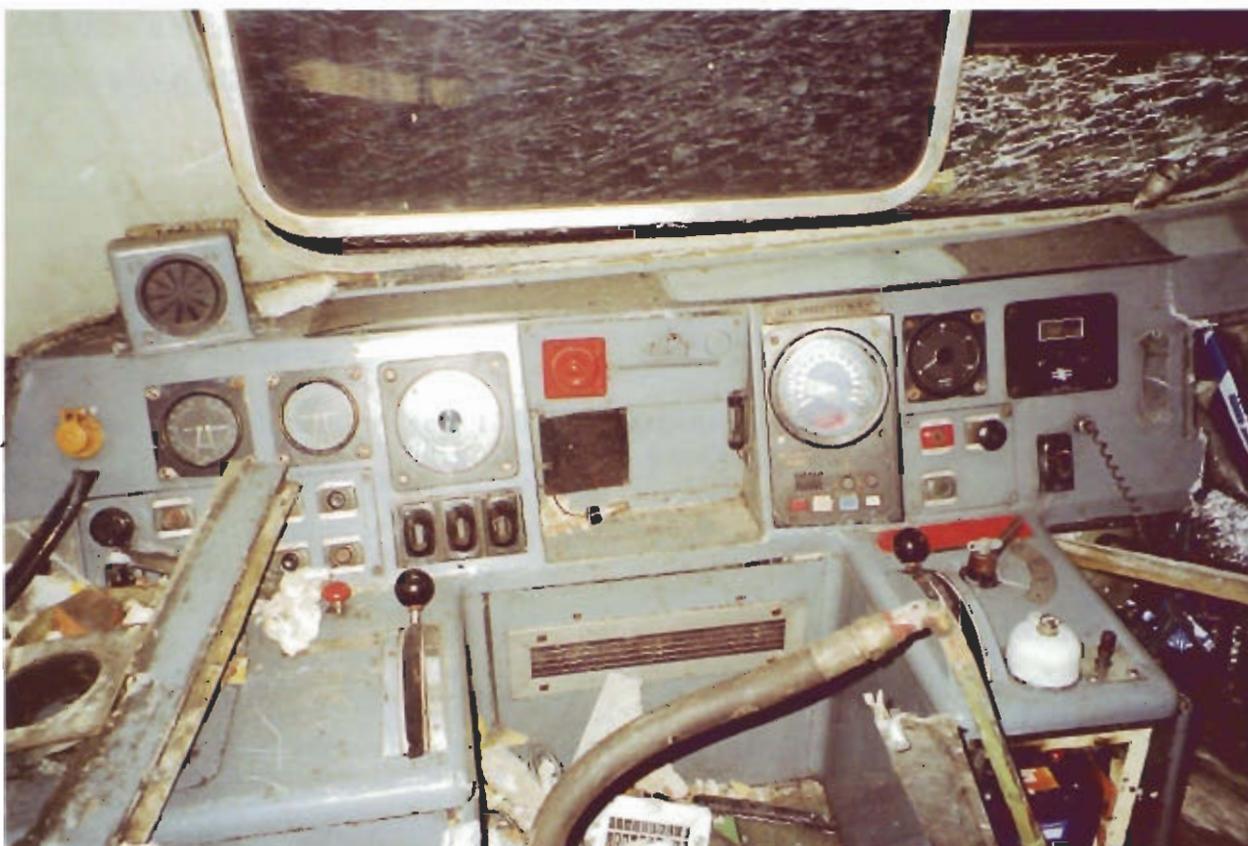
Driver's cab from Power Car 43173 Post Accident
