The explosion and fires at the Texaco Refinery, Milford Haven, 24 July 1994

A report of the investigation by the Health and Safety Executive into the explosion and fires on the Pembroke Cracking Company Plant at the Texaco Refinery, Milford Haven on 24 July 1994

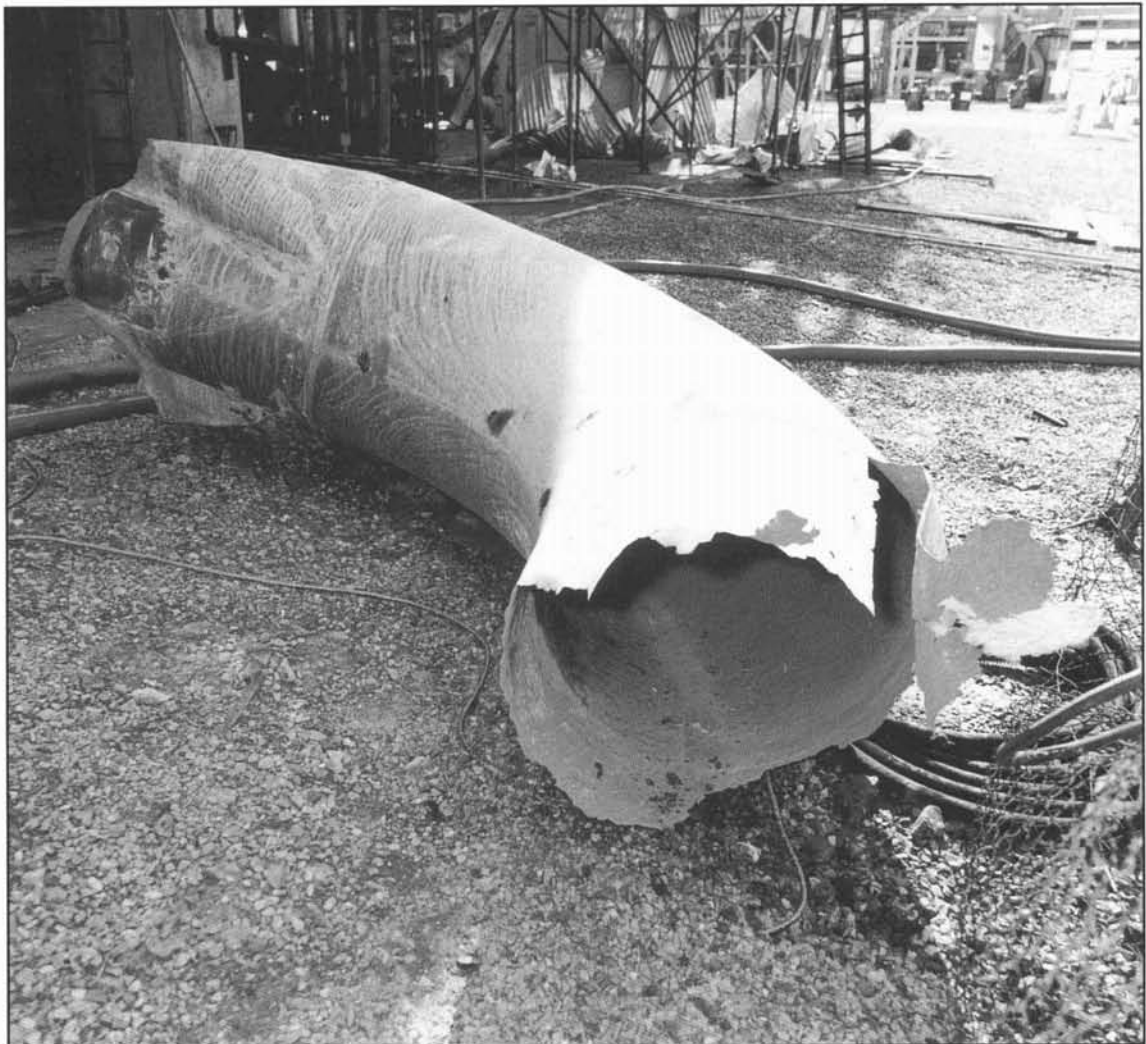
Figure 5 The 30 inch flare line elbow bend that failed and fell to the ground, releasing the hydrocarbon liquid and vapour

The flare drum outlet line which failed, releasing the hydrocarbon that exploded, was severely corroded. The presence of corrosion was known, but the full extent was not recognised because it had not been inspected at the point of failure, where there were inspection access difficulties. Although the flare line was clearly not properly maintained at this point, the investigation subsequently determined that this corrosion was not a direct cause of the incident.

remaining thicknesses down to 0.3 mm in the vicinity of the rupture were found when measurements of the failed elbow were made after the incident.

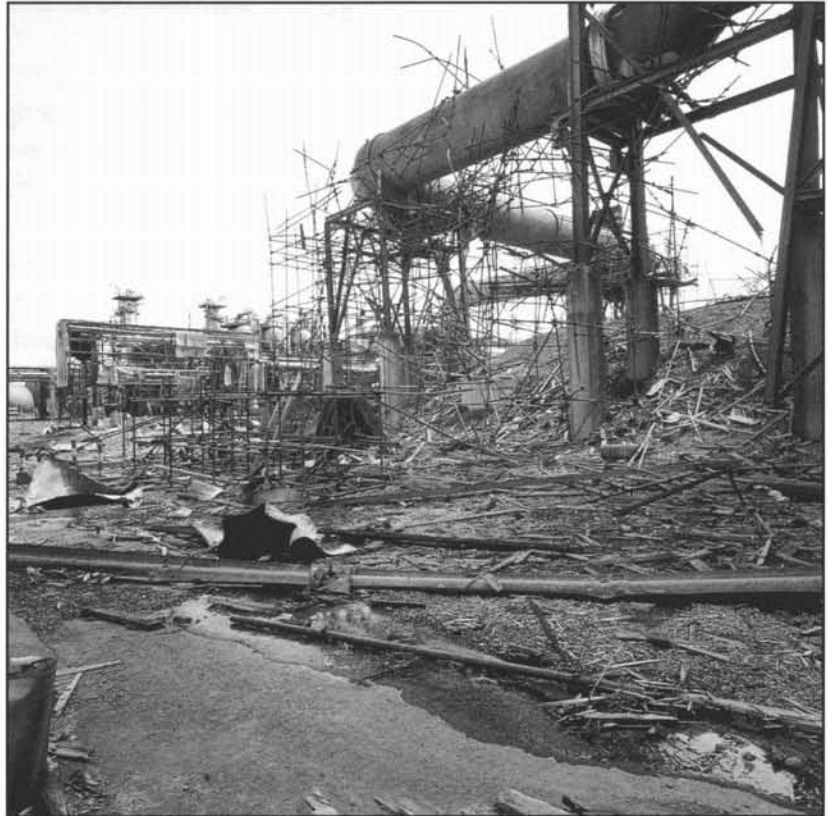
Figure 7 Some very large structures, such as the ducting weighing several tonnes shown here, were left balanced in dangerous positions after the explosion
