Joint Organisational Learning Action Note

Water Rescue Throw Lines – Safety Bulletin

Failure of a throw bag rescue line during a boat capsize rescue drill

MAIB SAFETY BULLETIN 2/2018

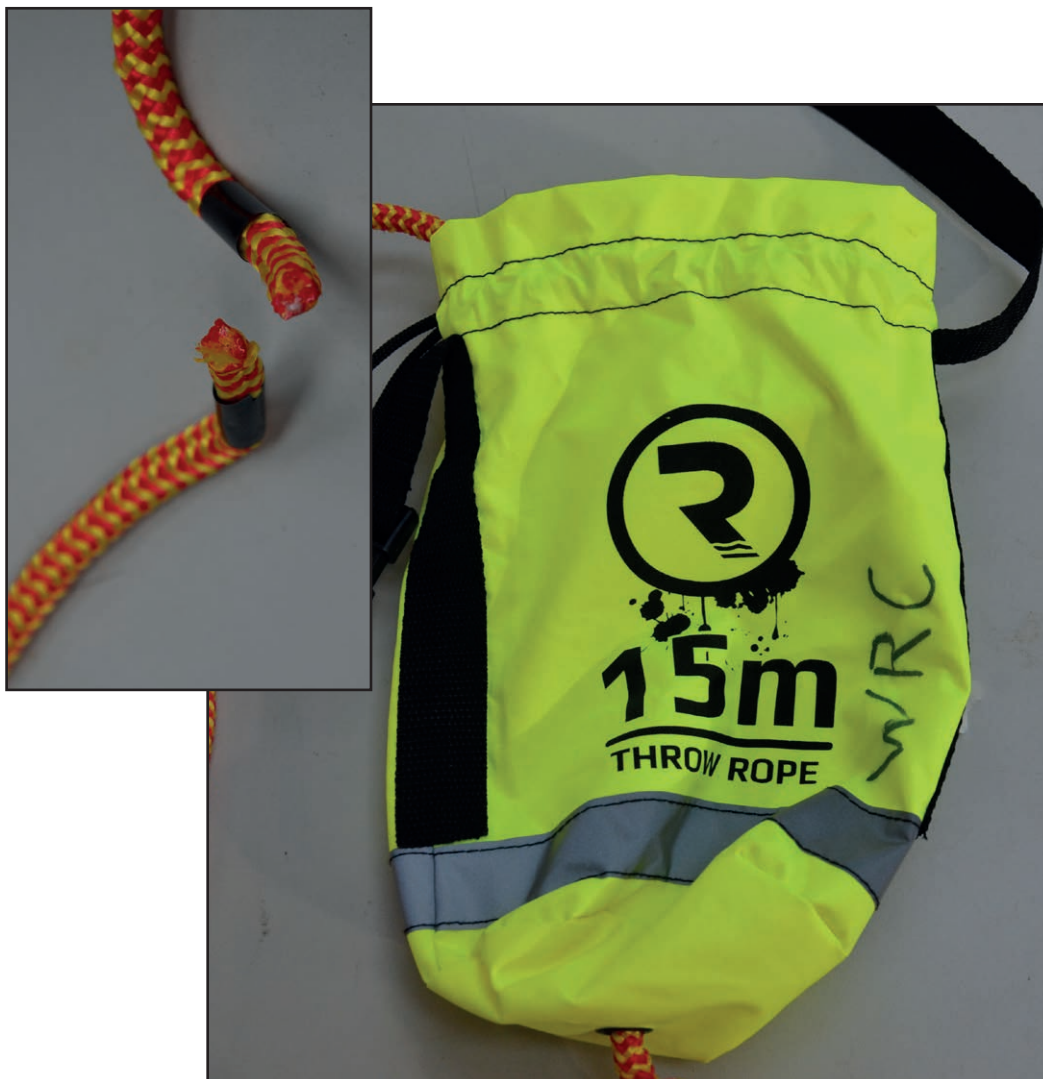
On inspection, the defective RIBER throw bag rescue lines identified by Warrington Rowing Club were found to have been made up of sections of polypropylene rope fused together, which broke easily at the joint when put under tension. One line was constructed of two sections of rope fused together, the other was constructed of four sections of rope, resulting in three fused joints in its 15m length (**Figure 3**). Intact and joined sections of one of the defective rescue lines were tested to determine the line's minimum breaking load. The intact section failed at 256 kgf (kilogramme force) and the joined sections failed between 19 and 23 kgf.

Any throw bag rescue lines found to have joins or discontinuities should be removed from service and the original manufacturer /supplier informed.
