The Southall Rail Accident Inquiry Report

Professor John Uff QC FREng

THIS Report follows an Inquiry held between September and December 1999 into the cause of a major rail accident which occurred on 19 September 1997 at Southall, 9 miles west of Paddington. The trains involved were the Great Western Trains (GWT) 10:32 Swansea to Paddington High Speed Train and a freight train operated by English Welsh and Scottish Railway (EWS), which was crossing the Up Main line to enter Southall Yard. Seven people died as a result of the accident and a further 139 people were injured, some severely. The Inquiry was set up within hours and directed to sit in public. The terms of reference are as follows :

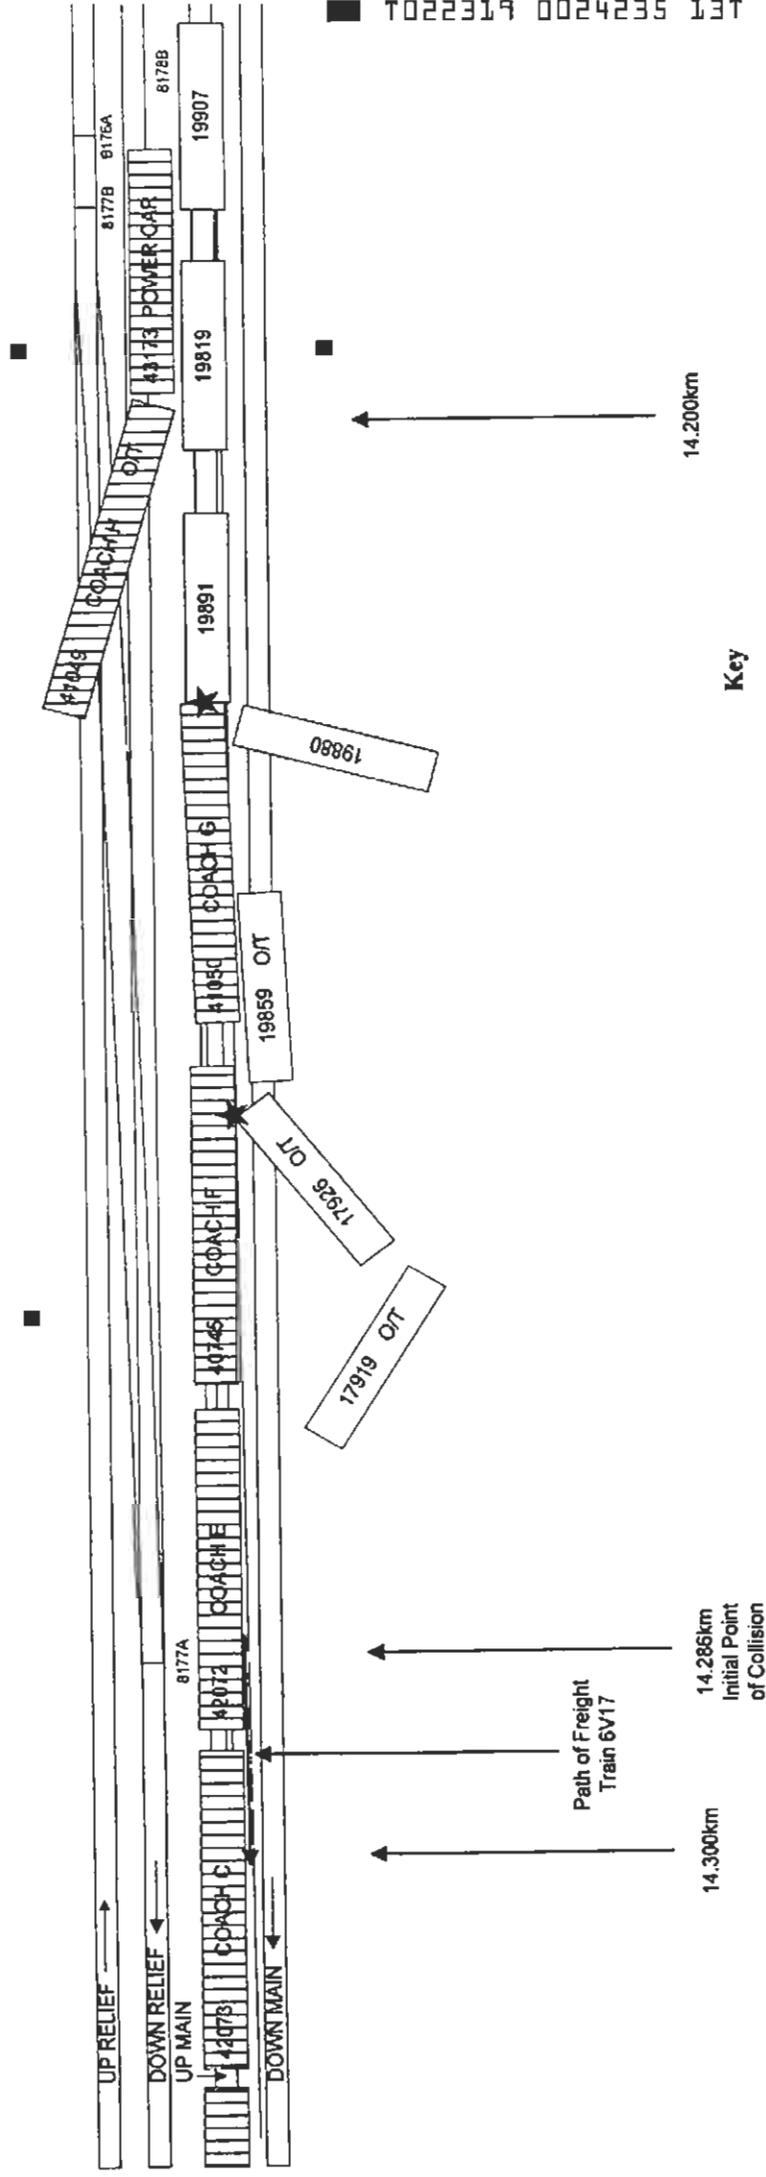
ANNEX 06B

Account of the reconstruction of collision events in the Southall rail crash

- Time 0.0 secs Initial impact at point of crossing (410m East of signal Sn 254) between HST power car 43173 and wagon 17906
- Time 0.3 secs Power car reaches rear of wagon 17906. Lateral interference is 0.5m, resulting in derailment of rear bogie of wagon 17906

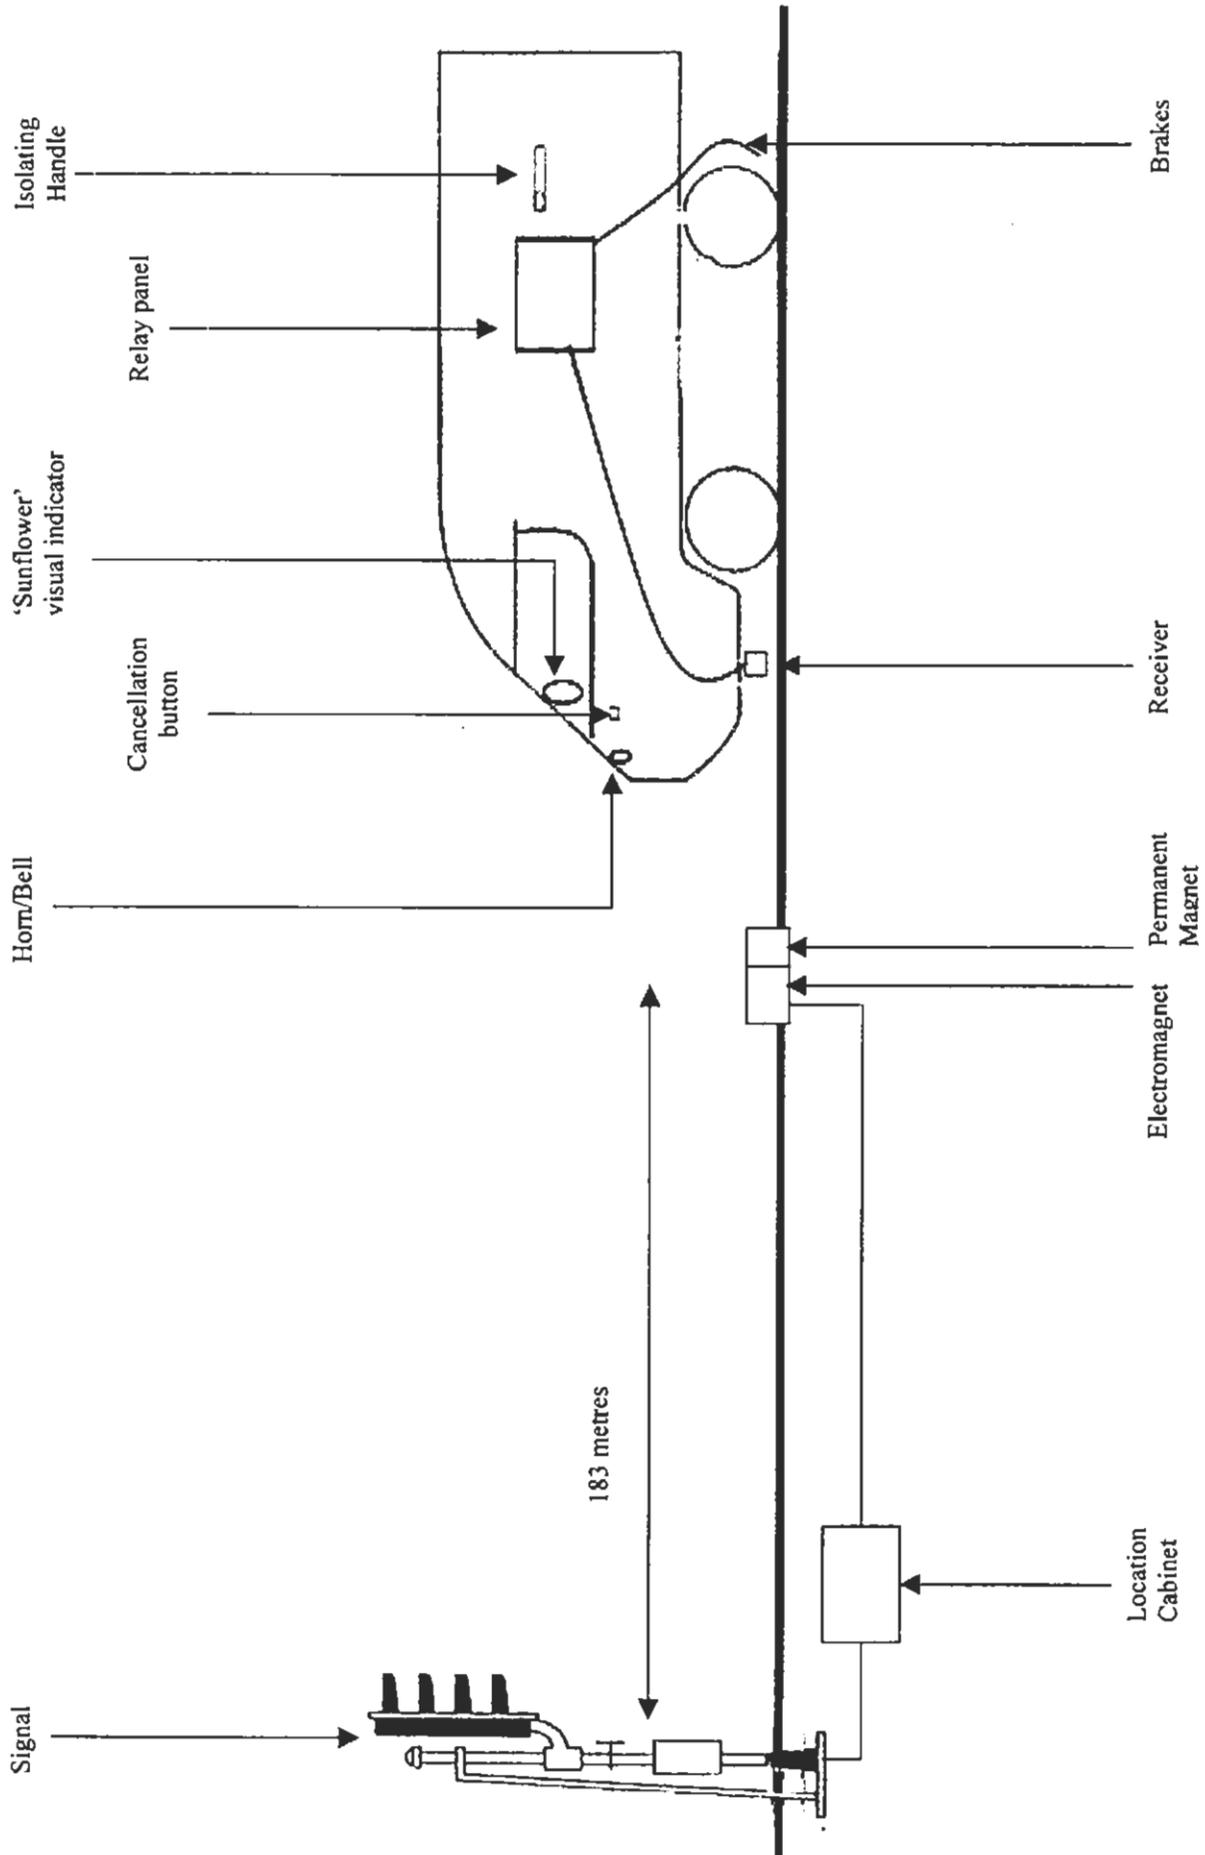
ANALYSIS OF GWT AWS IN SERVICE ISOLATIONS OVER THE PERIOD 01/01/97 TO 19/09/97 BY INDIVIDUAL EQUIPMENT

EQUIPMENT	NUMBER OF FAULTS
RECEIVER	24
RELAY PANEL	04
WIRING	5
CONVERTER	04
RESET BUTTON	01
NO FAULT FOUND	45
TOTAL	83
