The explosion and fires at the Texaco Refinery, Milford Haven, 24 July 1994

A report of the investigation by the Health and Safety Executive into the explosion and fires on the Pembroke Cracking Company Plant at the Texaco Refinery, Milford Haven on 24 July 1994

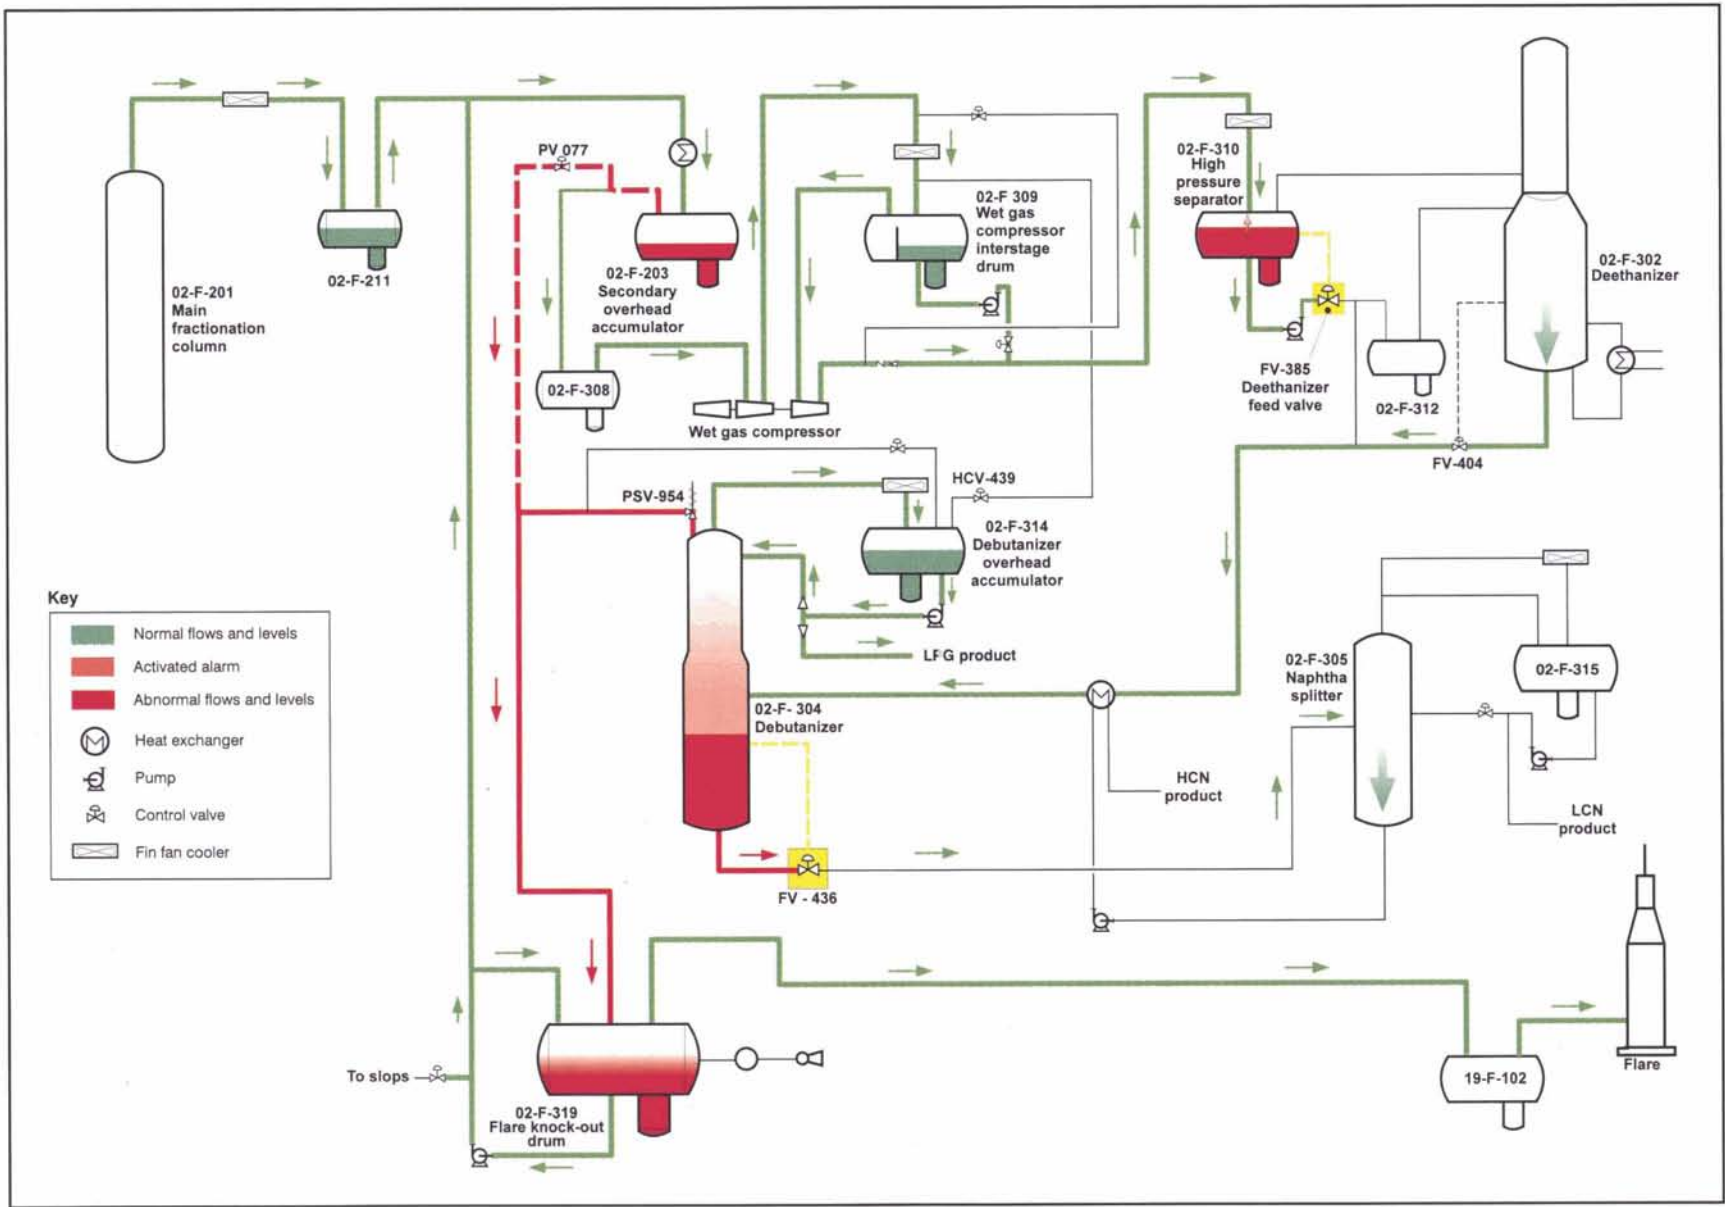
Figure 12

- 12 The pressure in the debutaniser rose because of the composition of the materials it contained. These included a high proportion of lighter fractions which would normally have been extracted by the deethaniser. On this occasion they had not been extracted because the deethaniser had emptied so quickly.

- 13 One of the four pressure relief valves (PSV954 A-D) on the debutaniser lifted (at

- around 08.53) and a mixture of gas and liquid was released to the flare knock-out drum (02-F-319).
- 14 The level in the flare knock-out drum rose from about 60% to around 70% within two minutes. This drum can be fed from two separate sources: the debutaniser (02-F-304) and the overhead accumulator (02-F-203).
 - 15 The level of liquid in the naphtha splitter had fallen to zero by the end of this period. It was to remain in this state, with no action taken, for some four hours.
 - 16 At 08.51 the reflux pumps that helped cool the debutaniser tripped (shut down automatically). The liquid level within the overhead accumulator was recorded as 30% by the TDC but this was probably erroneous. The recorded level had become static after a large amount of movement earlier in the morning.

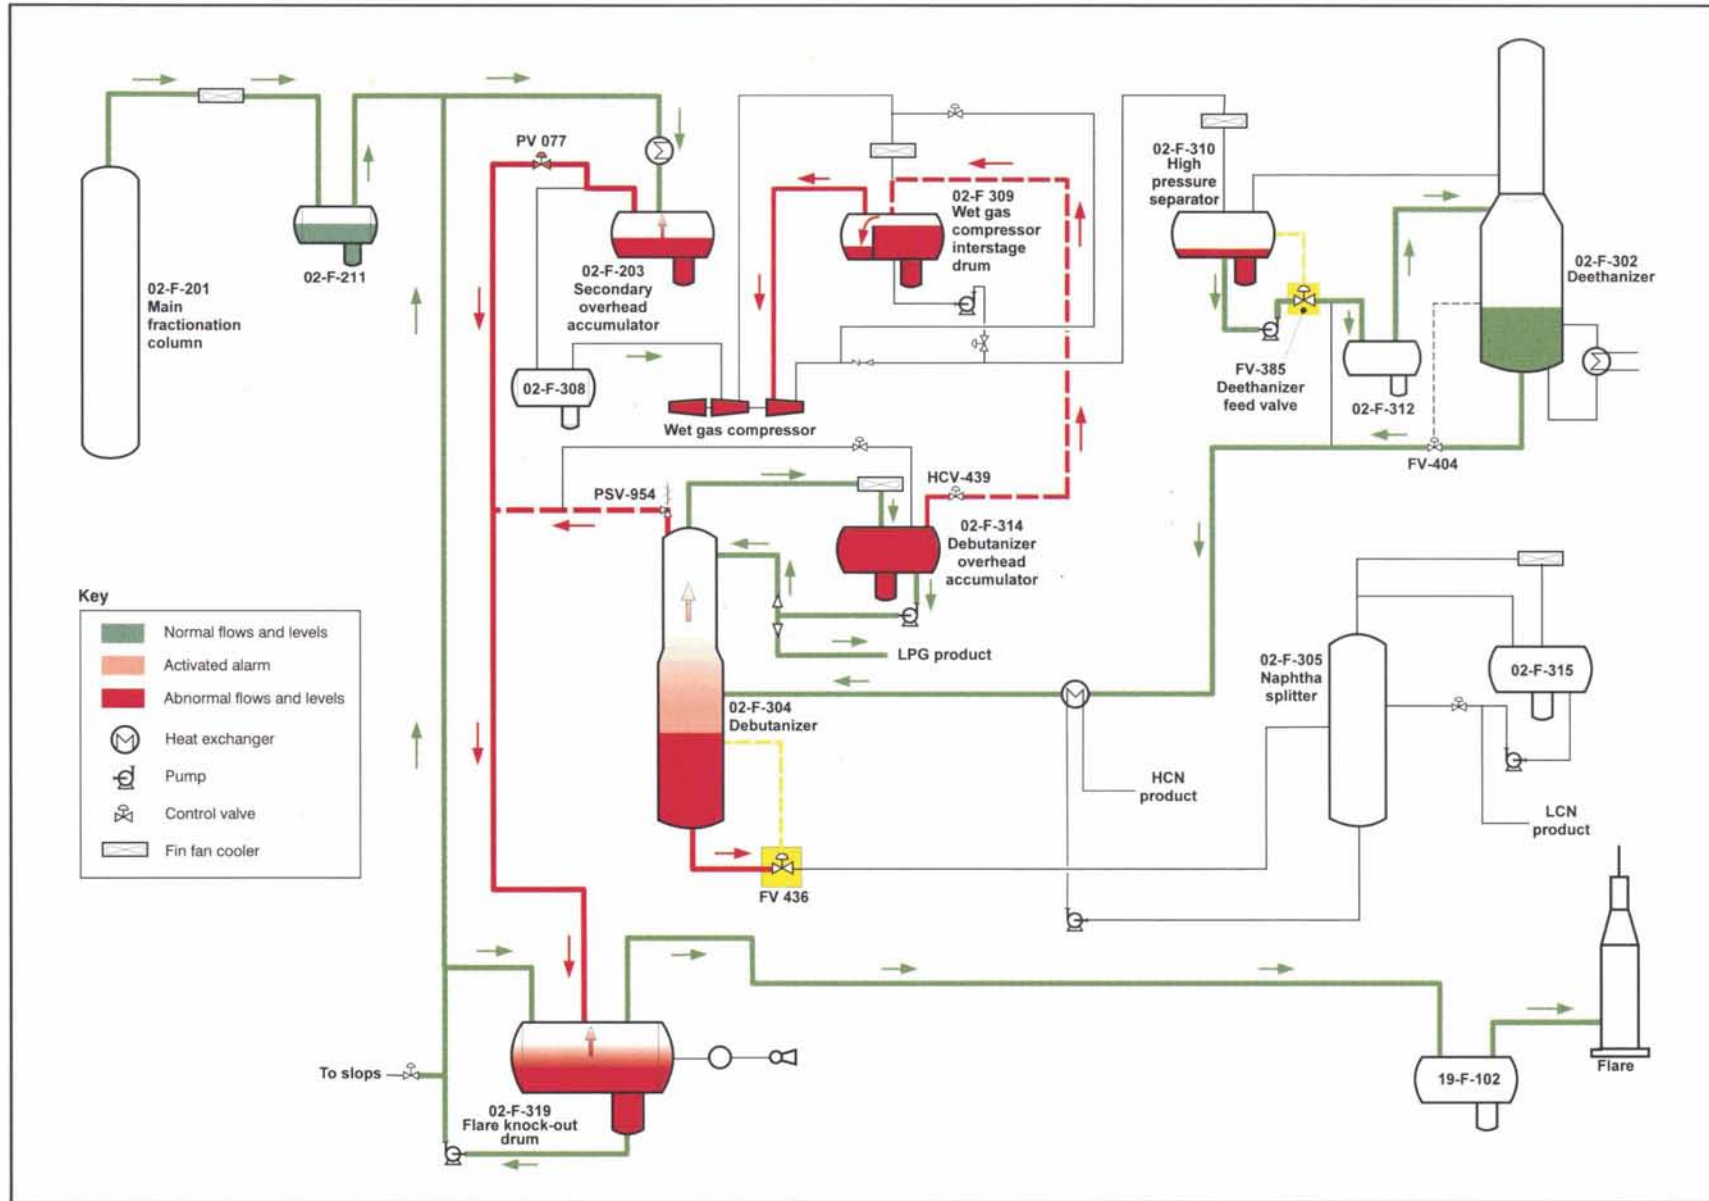
Figure 14

- 31 At 10.01 the debutaniser was liquid-logged and the pressure exceeded the PSV set pressure again. Pressure peaked at 12.2 barg and discharge via the debutaniser PSVs continued for 16 minutes. At 10.10 the liquid level in the knock-out drum began to rise rapidly, and rose from 61% to 93% over the next 14 minutes. This corresponded to an increase in liquid volume of 44 m³, and assuming a density of 630 kgm⁻³ (pentane), this represented a liquid flow rate of 33 kgsec⁻¹. This relief rate is consistent with that which could have discharged from the debutaniser PSVs.
