**mv HERALD OF FREE ENTERPRISE**

Report of Court No. 8074.

**Formal Investigation**

**The Roll on/Roll off passenger and freight ferry**

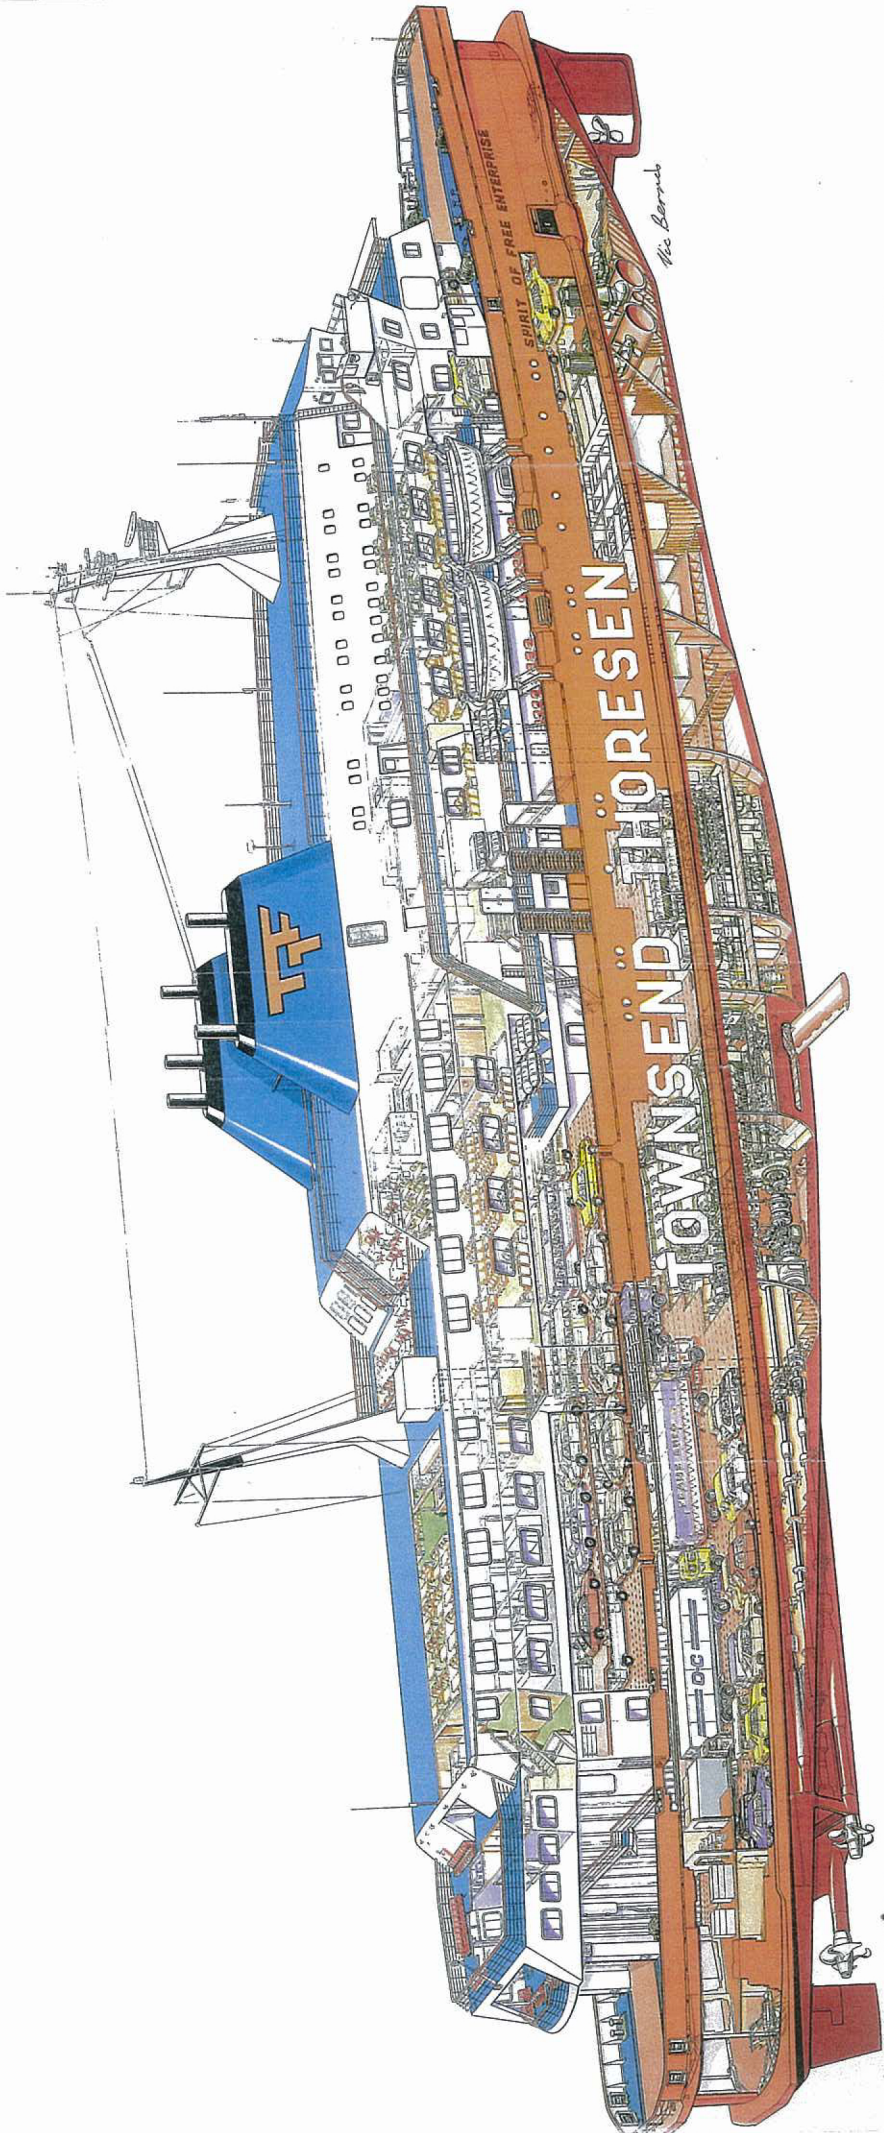
"SPIRIT OF FREE ENTERPRISE"  
TOWNSEND THORESEN Passenger & Vehicle Ferry  
Designed for "Motor Ship" by Vic Smith 1939
